CHANGE ORDER REQUEST

RE: Neenah Menasha Fire
Rescue Station 36
1108 Province Terrace
Menasha WI 54952

Report of Subgrade Preparation Observations

Project: Menasha Fire Station
Menasha, WI

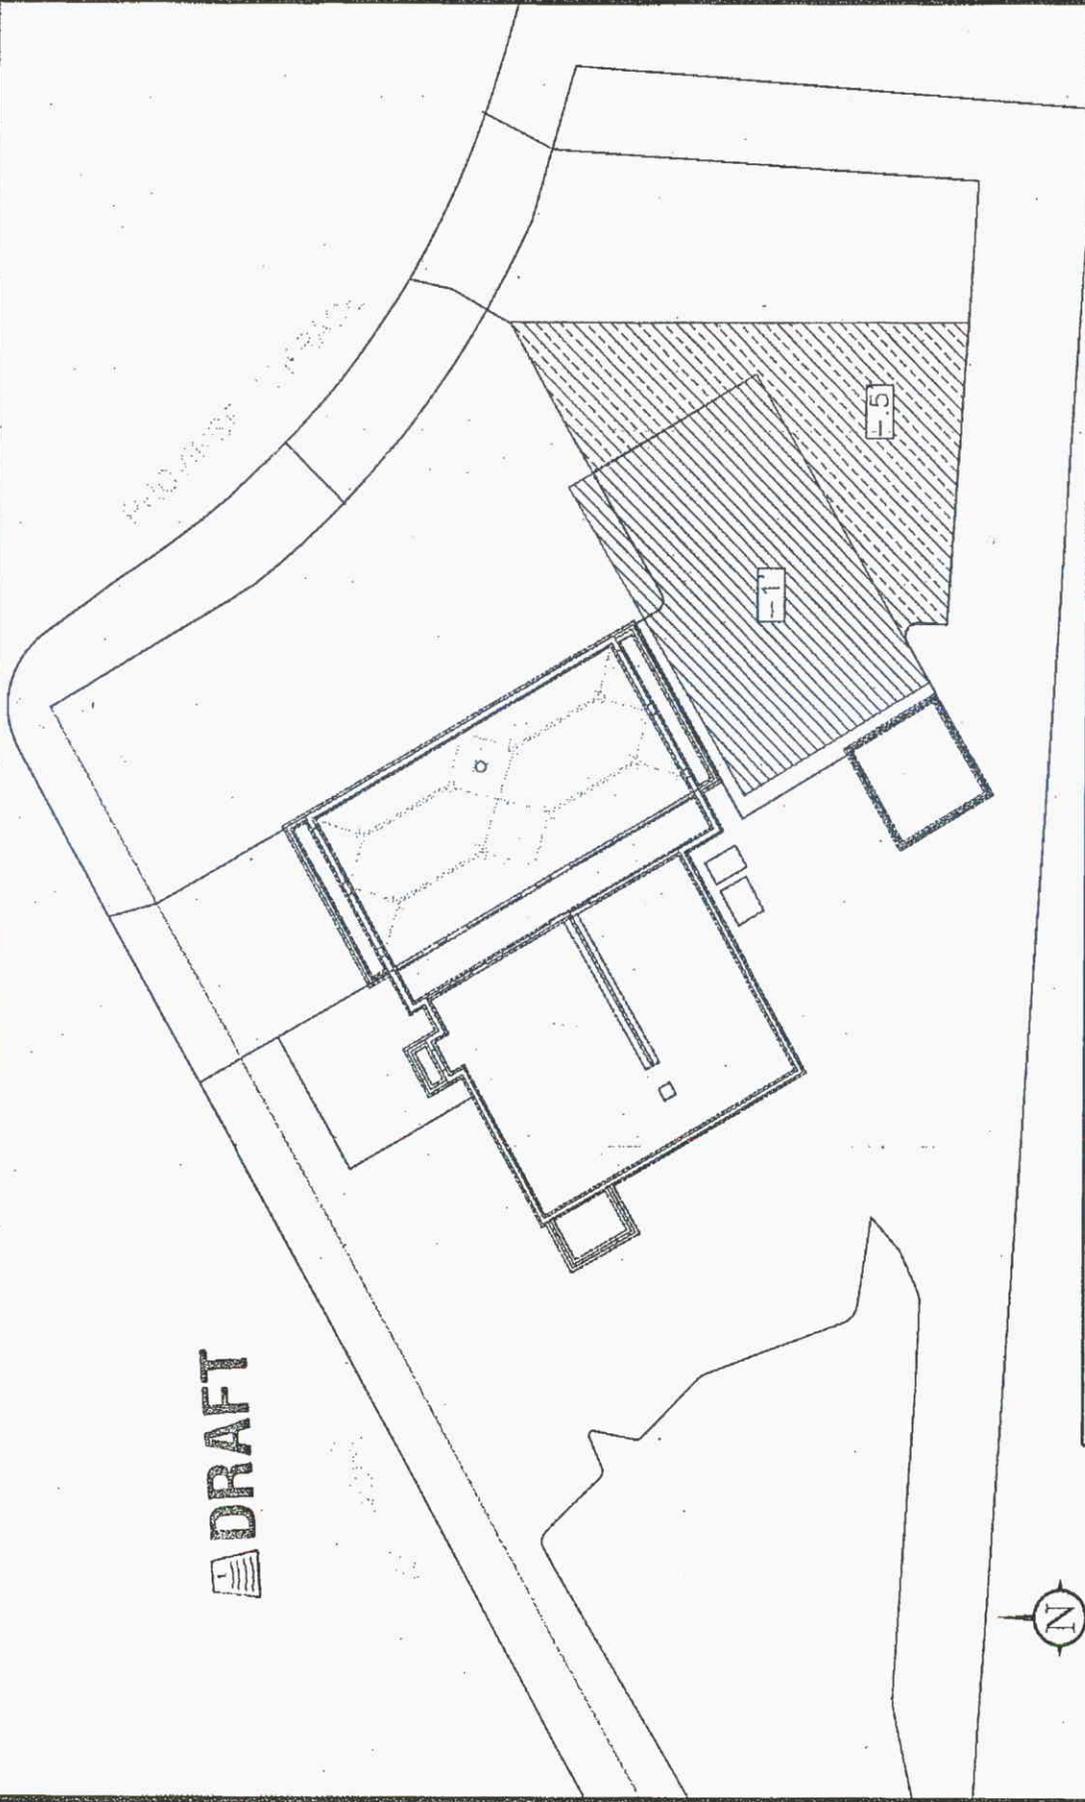
APPROXIMATE FIELD TESTING LOCATIONS DIAGRAM	Scale: 1" = 40'
	Project No:
MENASHA FIRE STATION MANITOWOC ROAD MENASHA, WISCONSIN	Date: 10/14/10
	Drawn By: KP

Major rolling and rutting was observed during proofroll in a area 50'x80'. MES recommended removing 1' of material and replacing it with compacted 3 inch breaker. Minor rutting and rolling was observed within the remaining area of the parking lot. Within this area, MES recommended removing 6 inches of material and replacing it with compacted 3 inch breaker. It is also recommended that fabric be placed prior to placing stone.
