CHANGE ORDER REQUEST

JOB #:101520
MOD #: 0007 -01
DATED: 10/26/10

RE: Neenah Menasha Fire
Rescue Station 36
1108 Province Terrace
Menasha WI 54952

Report of Subgrade Preparation Observations

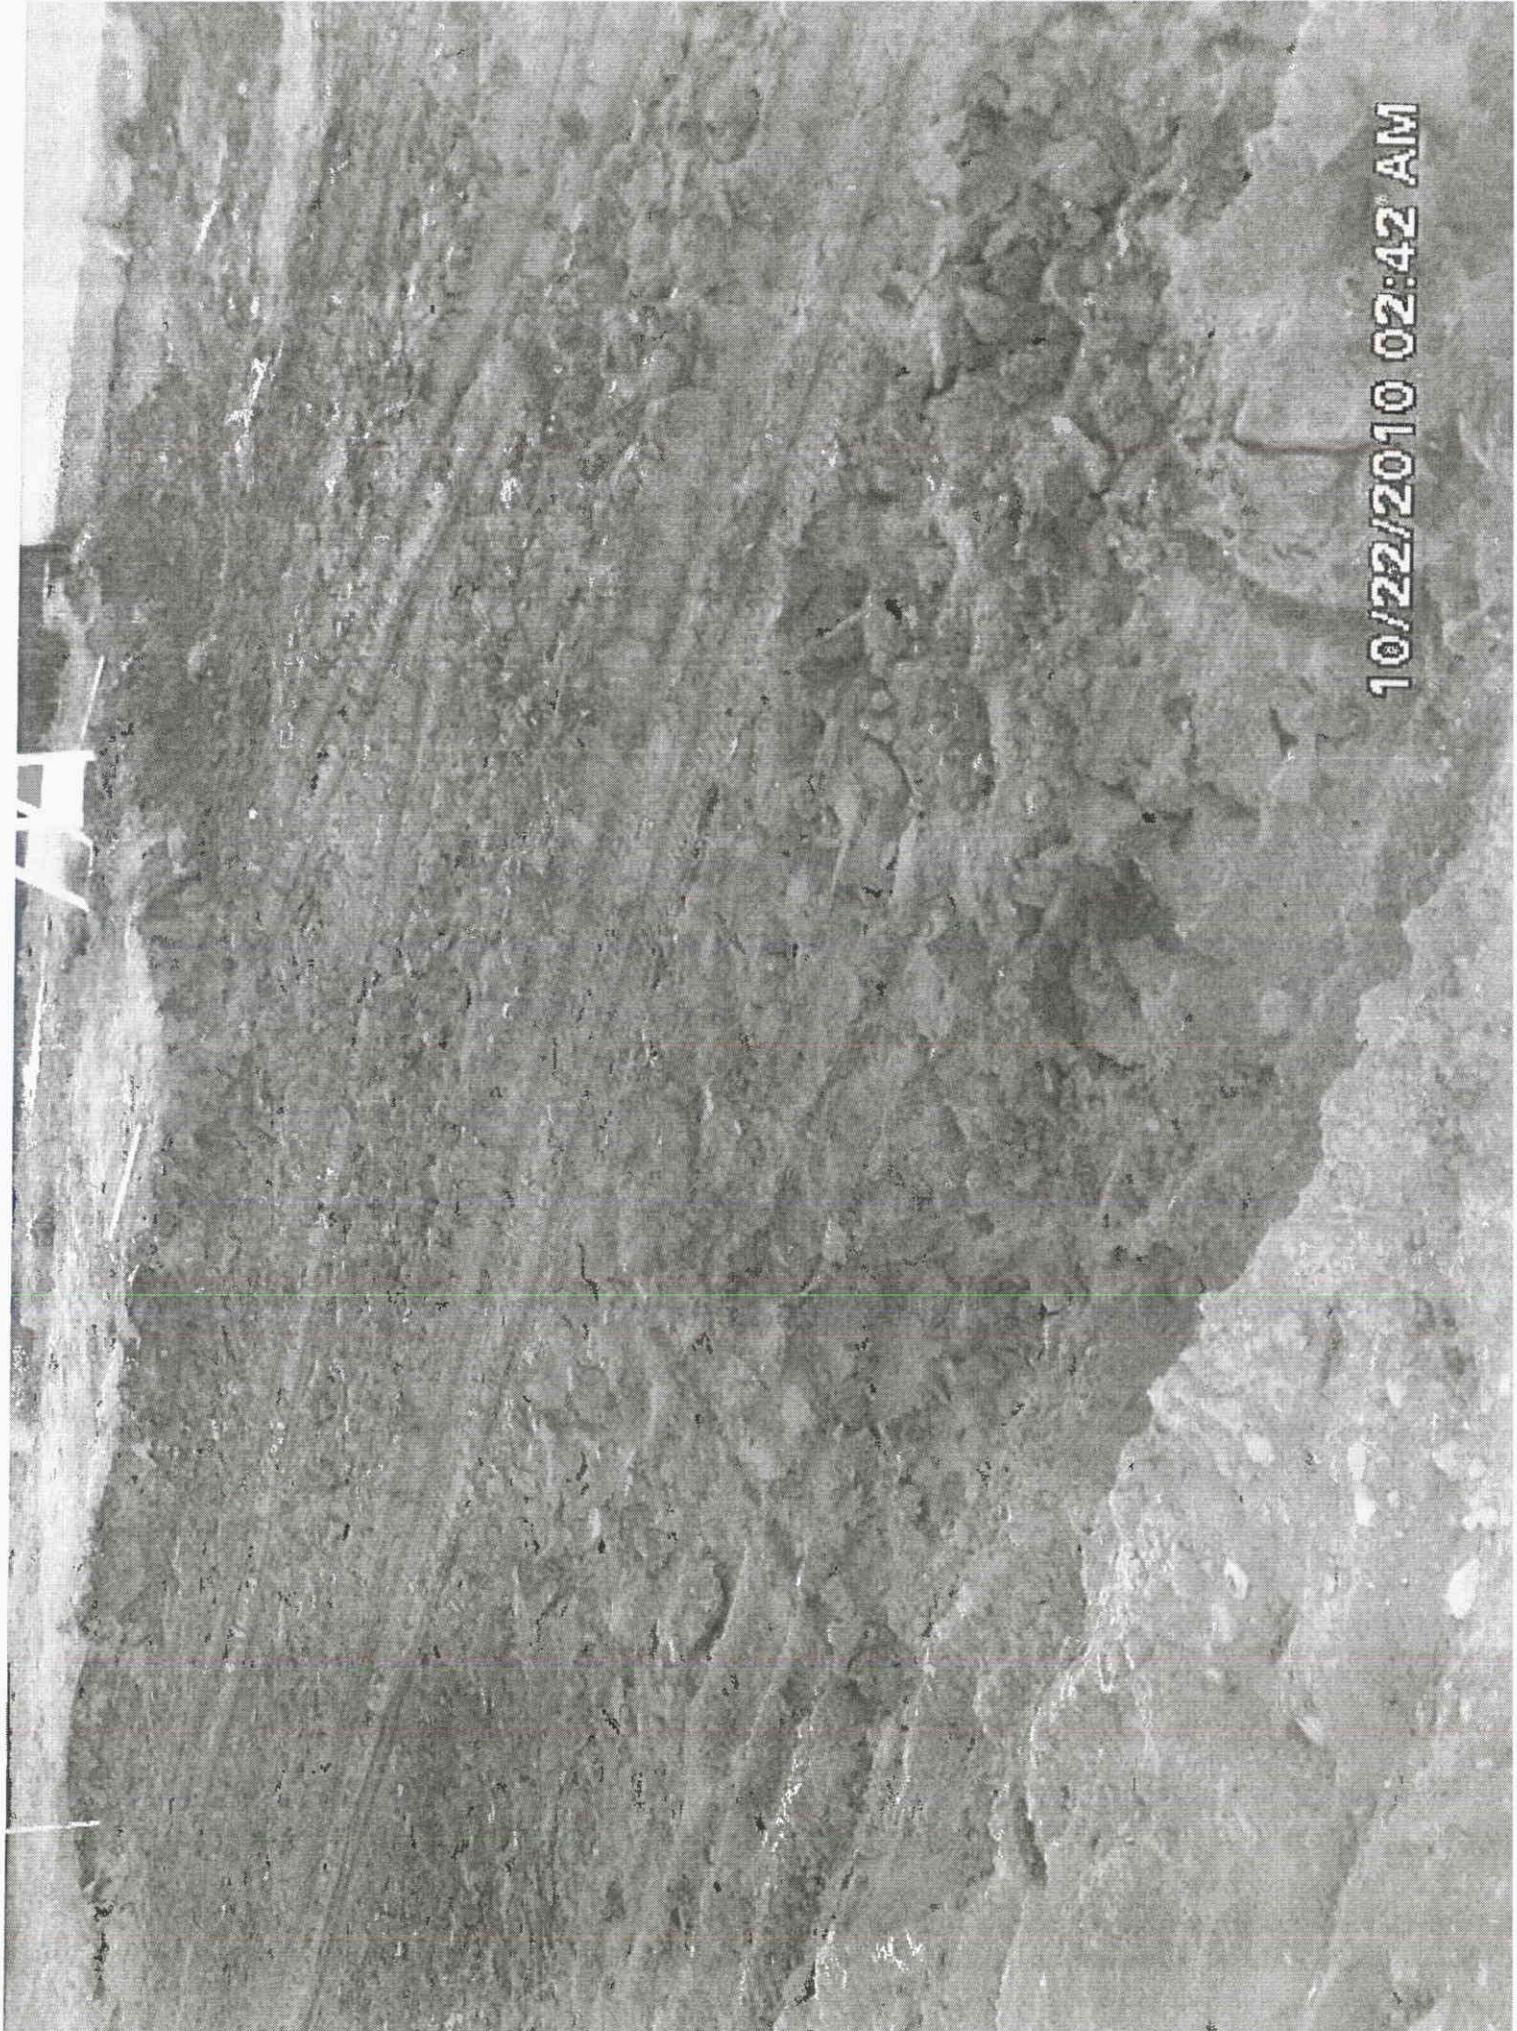
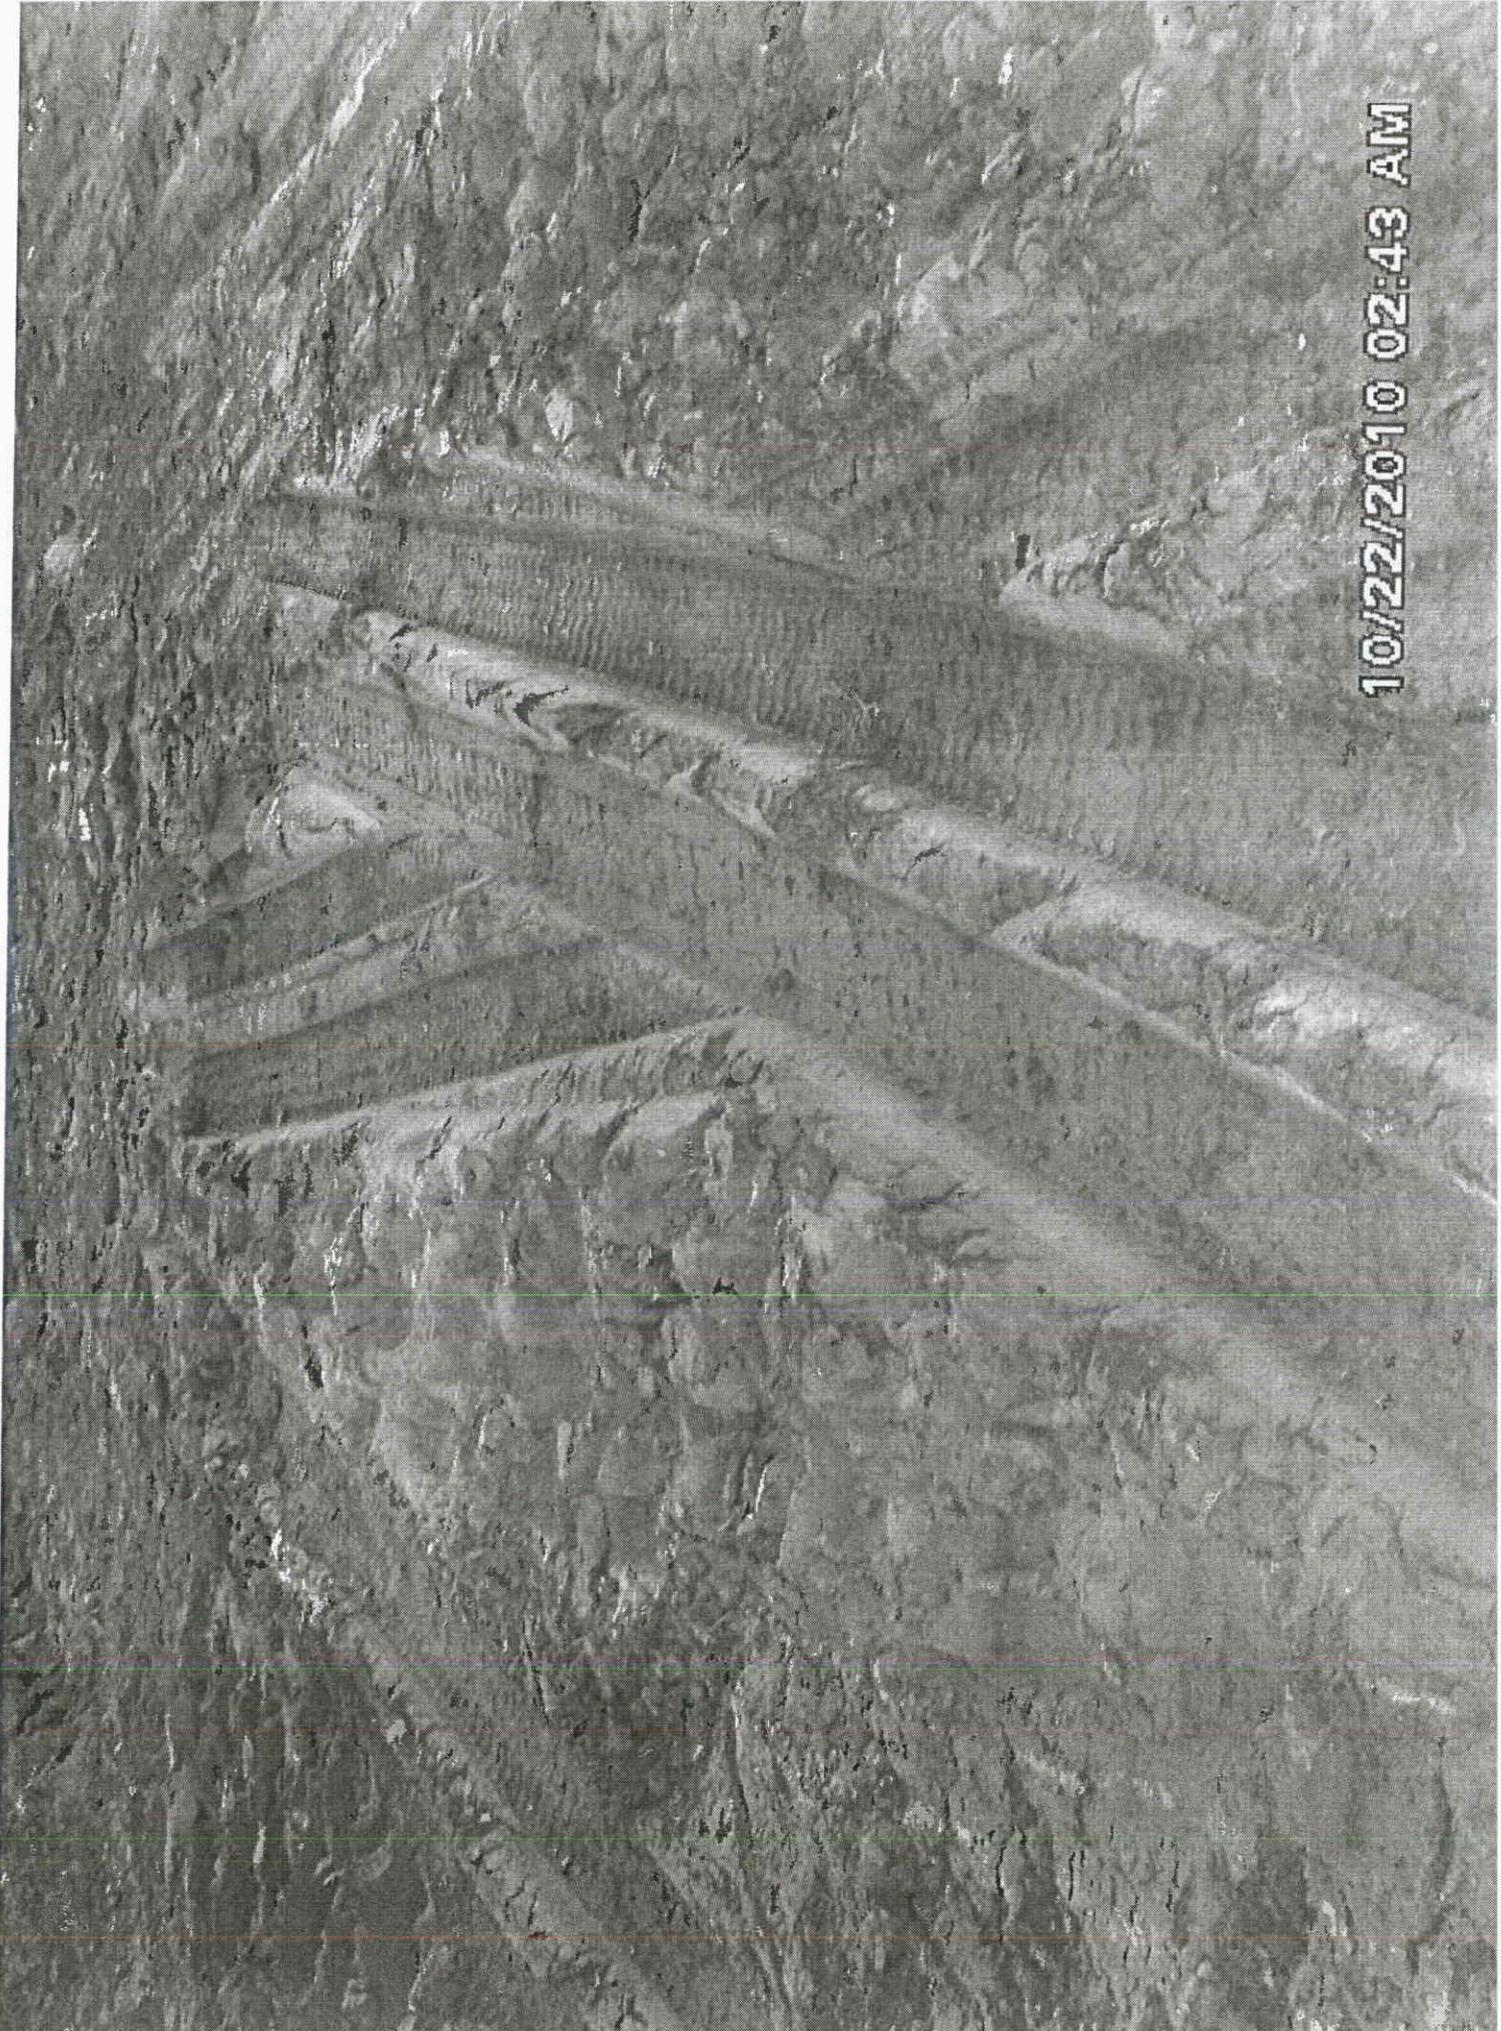
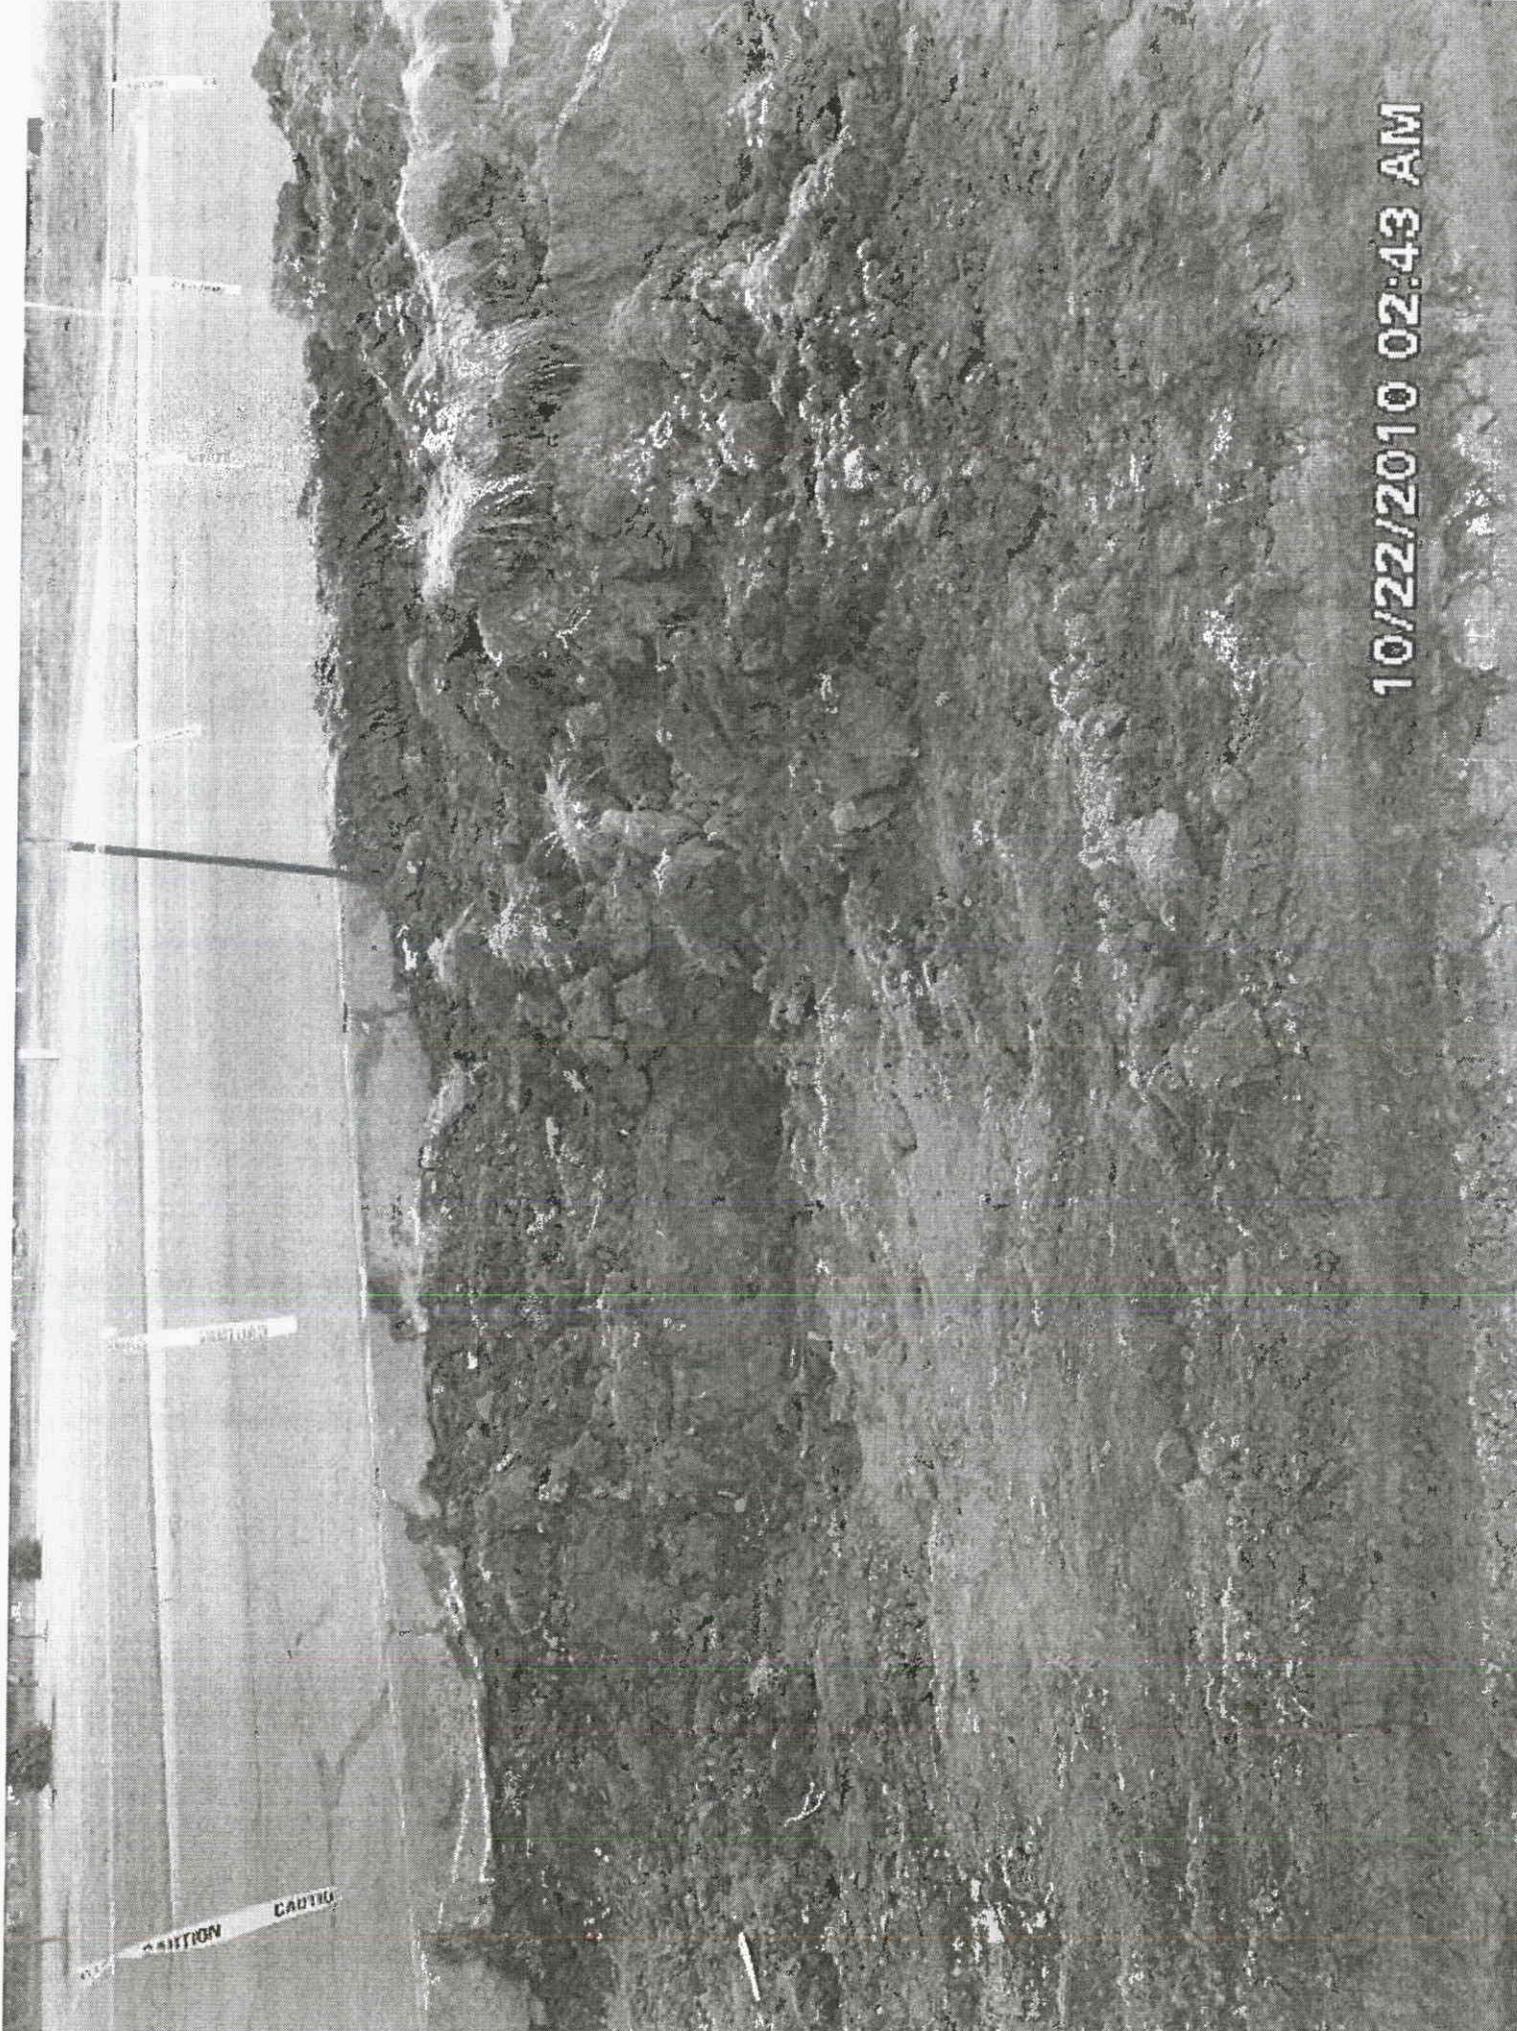
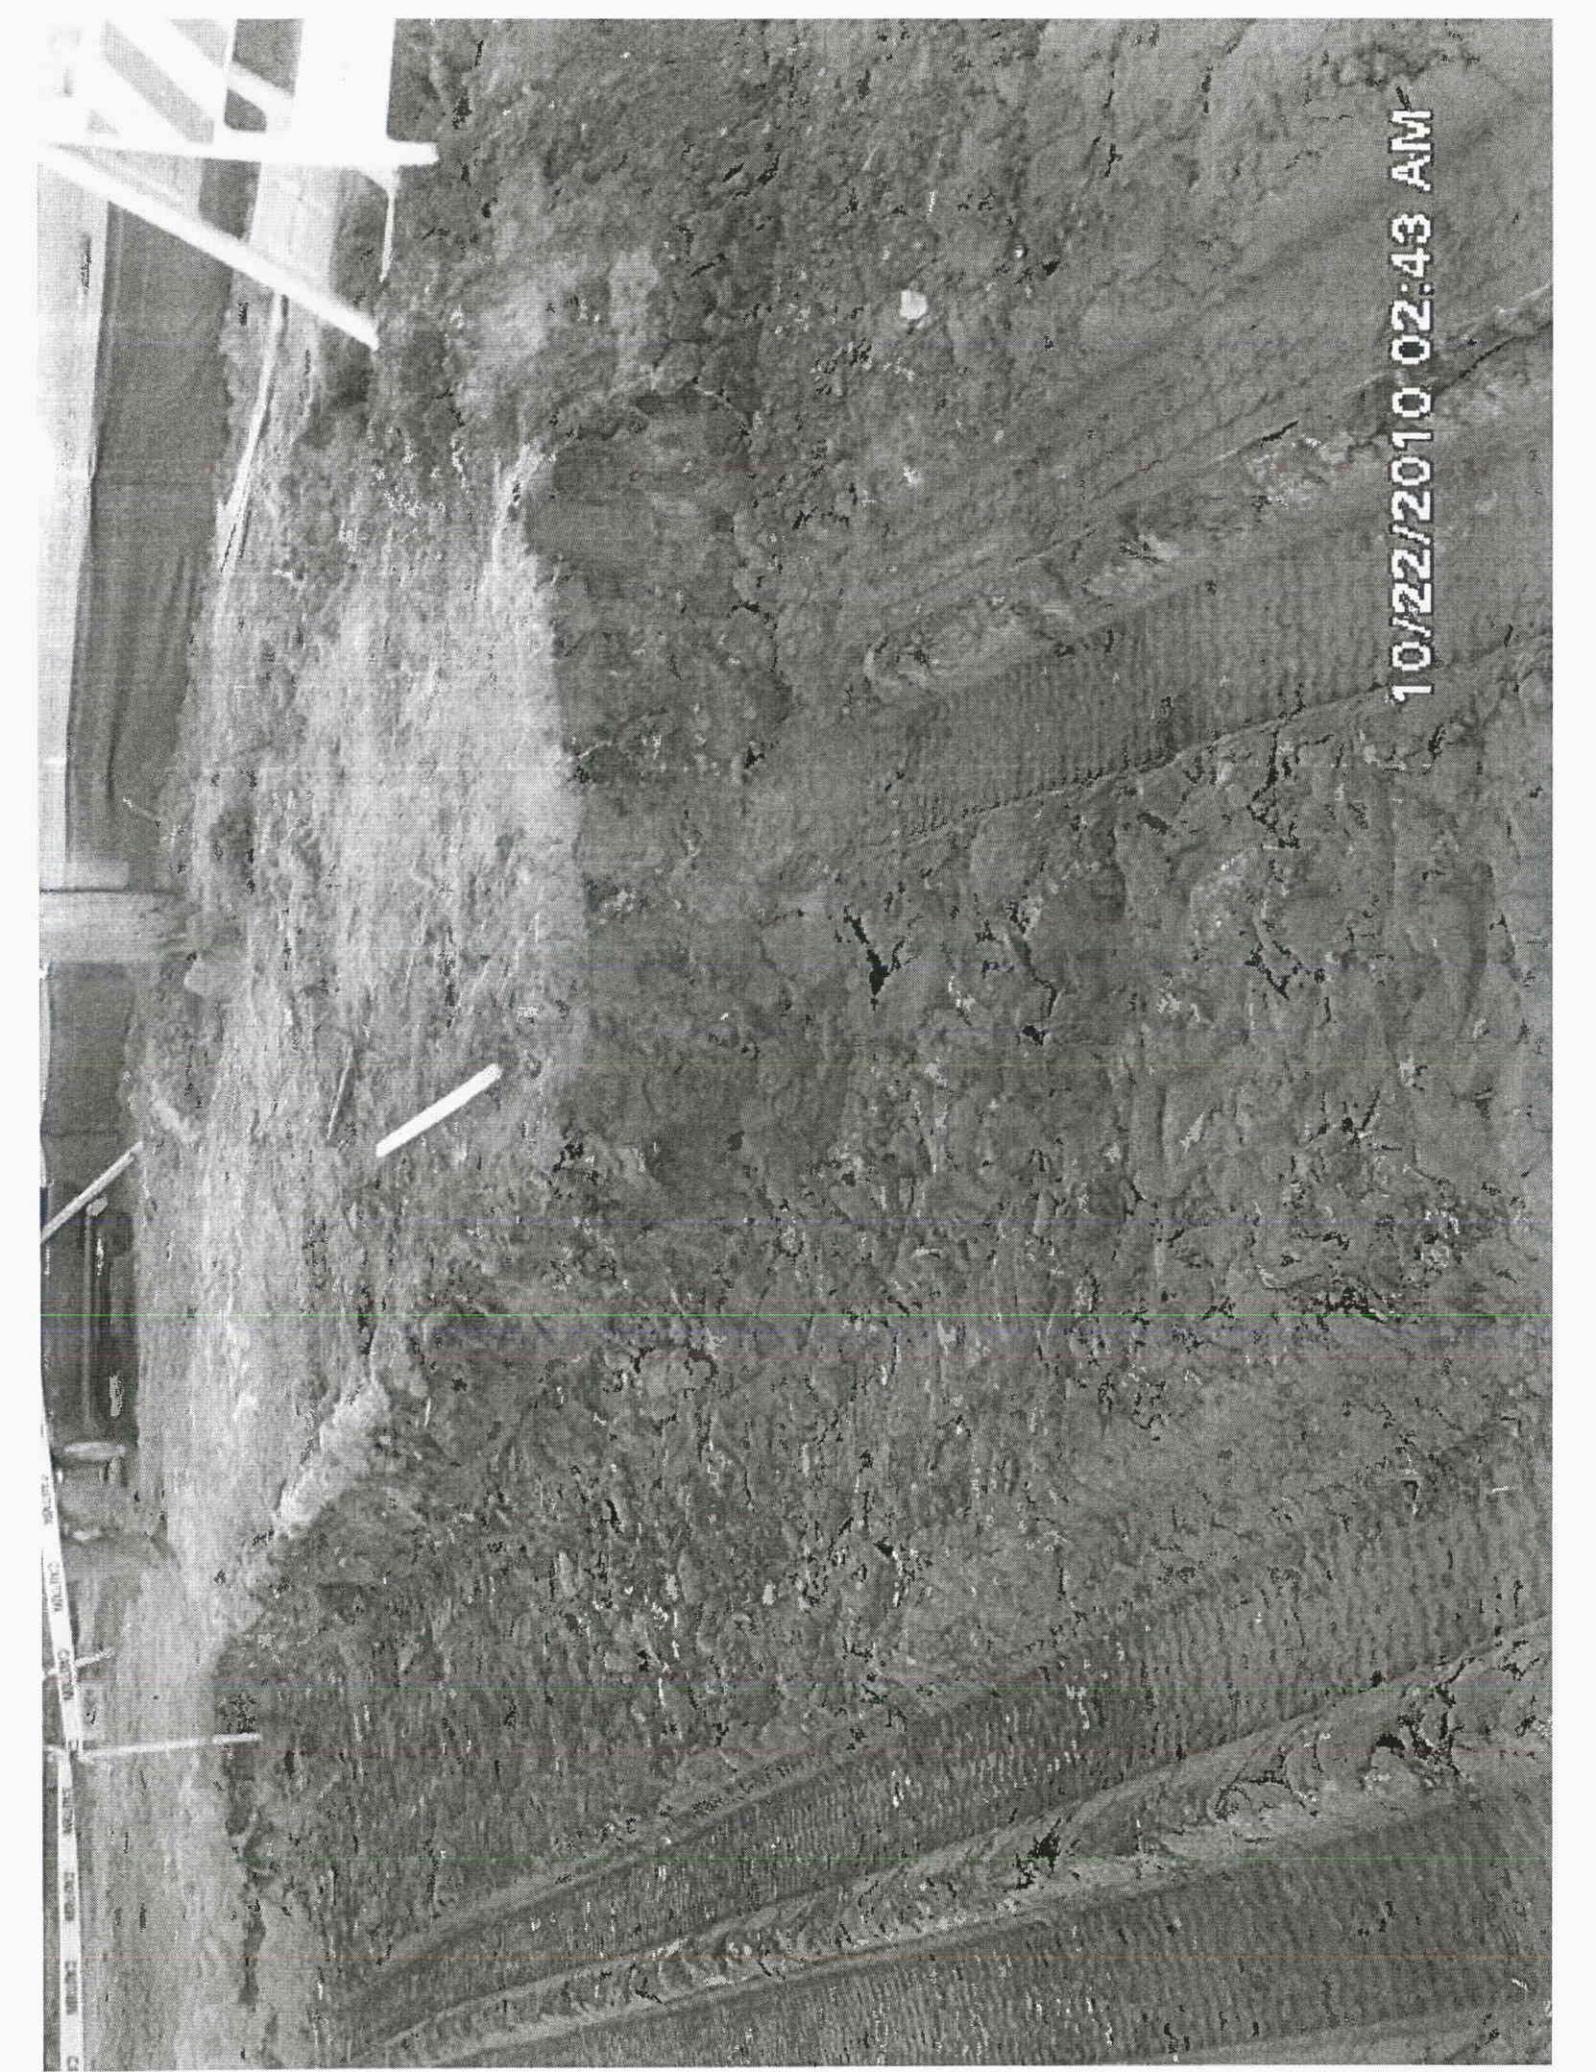
Subsequent to topsoil stripping, the grade was observed to be 10 to 26 inches below the design elevation. The subgrade was proofrolled and rutting was observed. Therefore MES recommended placing fabric and compacted 3 inch crushed gravel.
